SQUAW MOORING PROJECT  
FINAL REPORT  
VOLUME 1

**SQUAW MOORING PROJECT  
FINAL REPORT  
VOLUME 1**

**FPO-1-78(18)  
SEPTEMBER 1978**

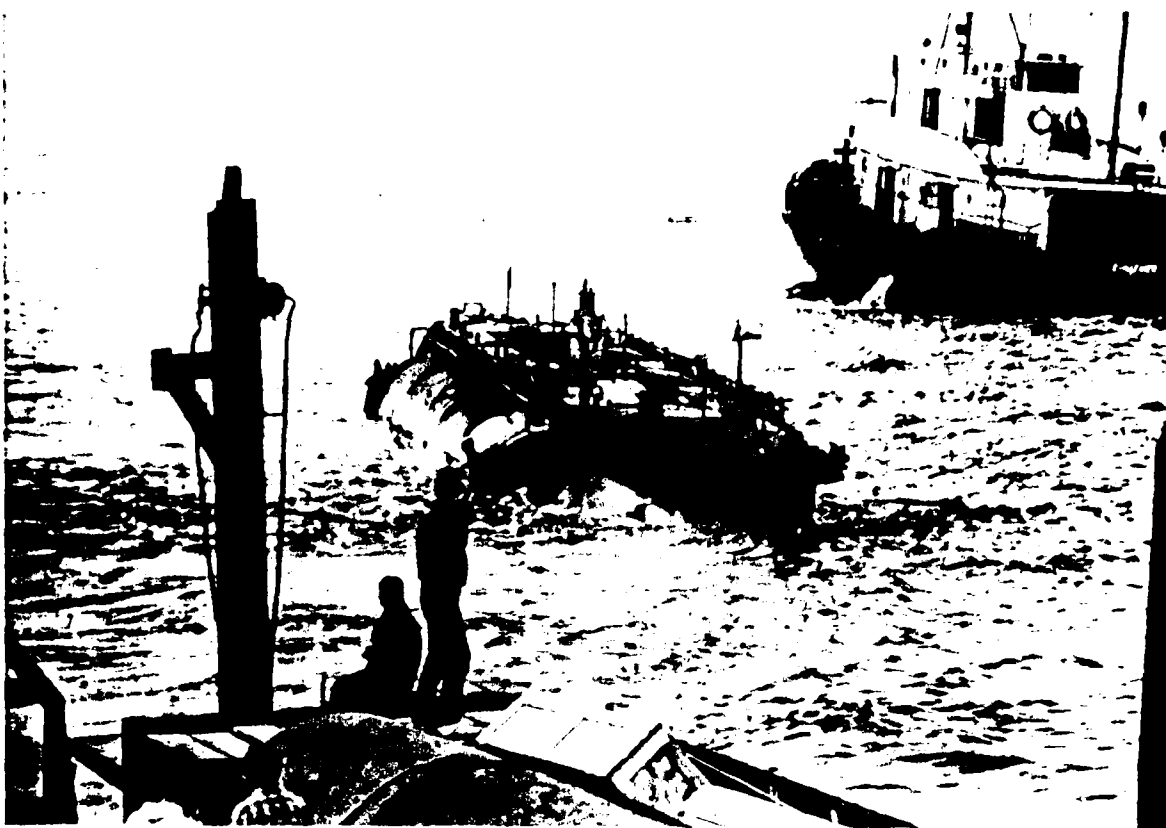
The 45 feet of chain at the bow of the *SQUAW* was brought aboard the *MANATI* at about 0800. The length was quite short and drew the bow of the *SQUAW* almost snubbed up to the stern of the *MANATI* as the chain was made fast, Figure 7. The eye at the end of the 8570 foot mooring line was shackled to the chain and overboarded.

FIGURE 7. THE MANATI, SQUAW, AND CHALLENGER DURING HOOKUP

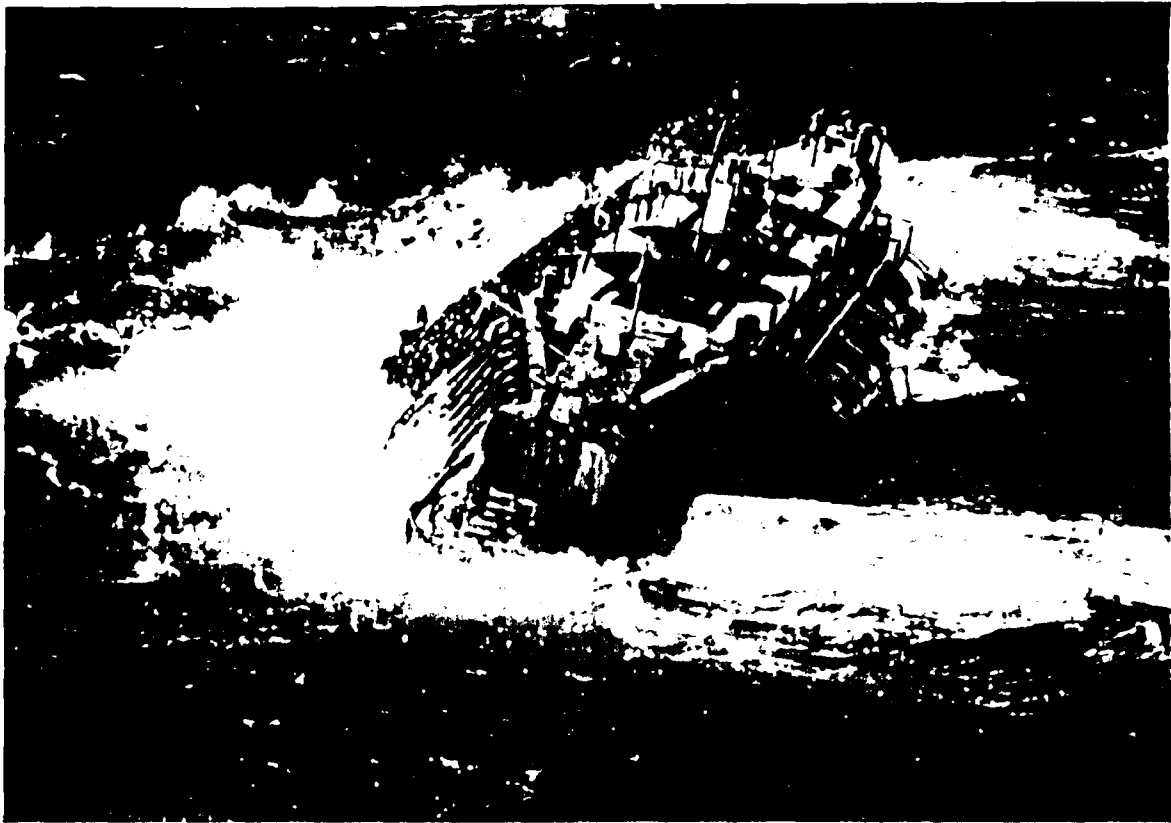
Back on station the seas were too rough to do any work. The *SQUAW* had moved about 3500 feet north of where it was left on 1 July, the day before. The crown buoy position was in the same general area where it had been cut loose. This indicated that the south anchor was where it had been left the day before. The *MANATI* proceeded then to make another check on the *SQUAW* and found it about 1000 feet from the earlier position. On the first sighting the *SQUAW* was headed 280° and on the second 315°, each time directly into the seas whereas when left on 7/1/78 she had a precise north-south orientation.

FIGURE 17. SQUAW WITH NORTH AND SOUTH MOORS IN PLACE

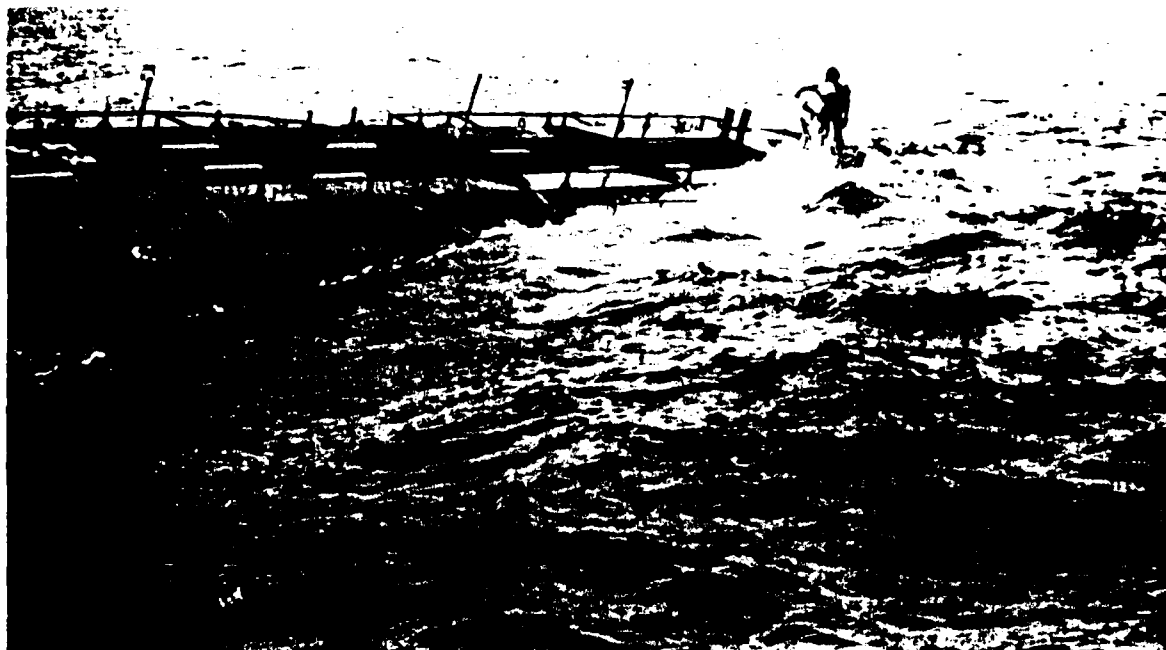
Prior to cutting the forward vertical leg 1 1/4 inch lowering line off the after bitts, divers went down to secure a carpenter stopper on the line about 100 feet below the surface. They went aboard the submarine with a burning torch and proceeded to cut the wire just outboard of the bitt, Figure 35. When the wire was cut through and dropped, the line from the *MANATI* to the carpenter stopper went slack almost immediately. The carpenter stopper did not hold the load. The *SQUAW* gradually trimmed up to an even keel condition and the list to port came off to be replaced by a slight list to starboard. In retrospect this is a possible point in time when the after vertical leg parted and the submarine was relieved of the weight of the 28000 pound clump.

FIGURE 35. SQUAW PRIOR TO CUTTING LOWERING LINE FROM AFTER BITTS

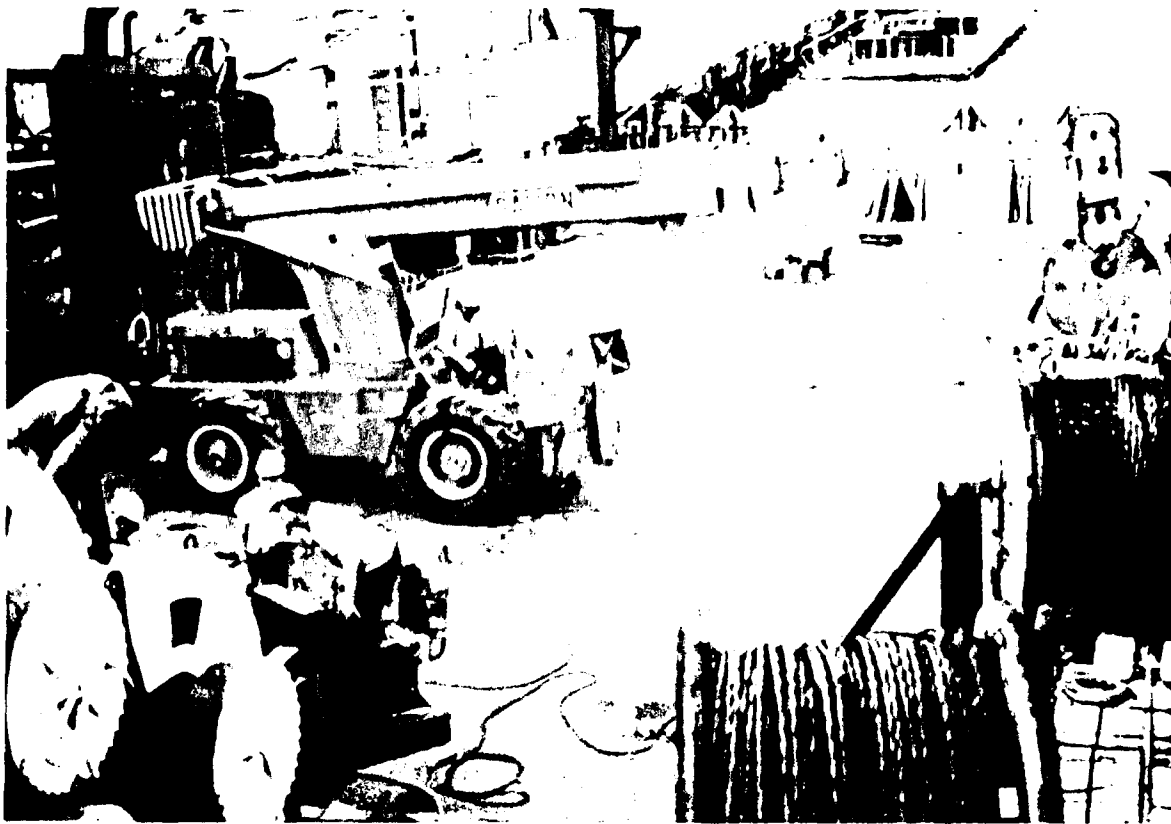
For handling weights of any significant magnitude, the wire should be level wound on the winch drum under heavy tension. The provision for this heavy tension level winding is shown in Figure 38. Essentially, the wire was fed off the cable reel and around a horizontal sheave welded to the deck near the stern on the centerline. From there the wire passed through a pair of wooden blocks that were bolted to a frame welded to the deck; the bolts could be tightened to increase the friction loading on the wire passing between the blocks. Leading from the fixed tensioning blocks, the wire passed through a similar pair of blocks that were affixed to the bumper of a mobile crane, passing from there to the winch drum. As the wire was wound on to the drum, the crane would be driven back and forth across the deck in an attempt to achieve a tightly wrapped level wind.

Many deficiencies of this tensioning-level wind system existed. It was inadequate as far as tensioning was concerned and any cable wrapped in this manner could not be used to lower a load of any significant magnitude. Furthermore, to achieve any reasonable tightness of the wrap in an axial direction, the mobile crane had to be jockeyed back and forth and sledges were used to drive the wraps together on the winch drum. This process was extremely slow and inefficient.

FIGURE 38. TENSIONING AND LEVEL WINDING SYSTEM

One way that a wire could be wound on a winch drum under a workable tension was first to wind it on to the reel as described above, then use it to lower a medium sized clump overboard, unwinding the entire drum. Then the drum would be respooled under the combined tension of the clump and cable weight, using the mobile crane to get a level wind. Figure 39 shows that a tight level wound spooling job could be done in this manner but the time consumed in doing so was disproportionate to the results obtained. An alternative tensioning means was to connect the wire to another of the vessels, reel it out, and then reel it back in under tension while towing the other vessel. This technique was used once successfully but proved equally time consuming.

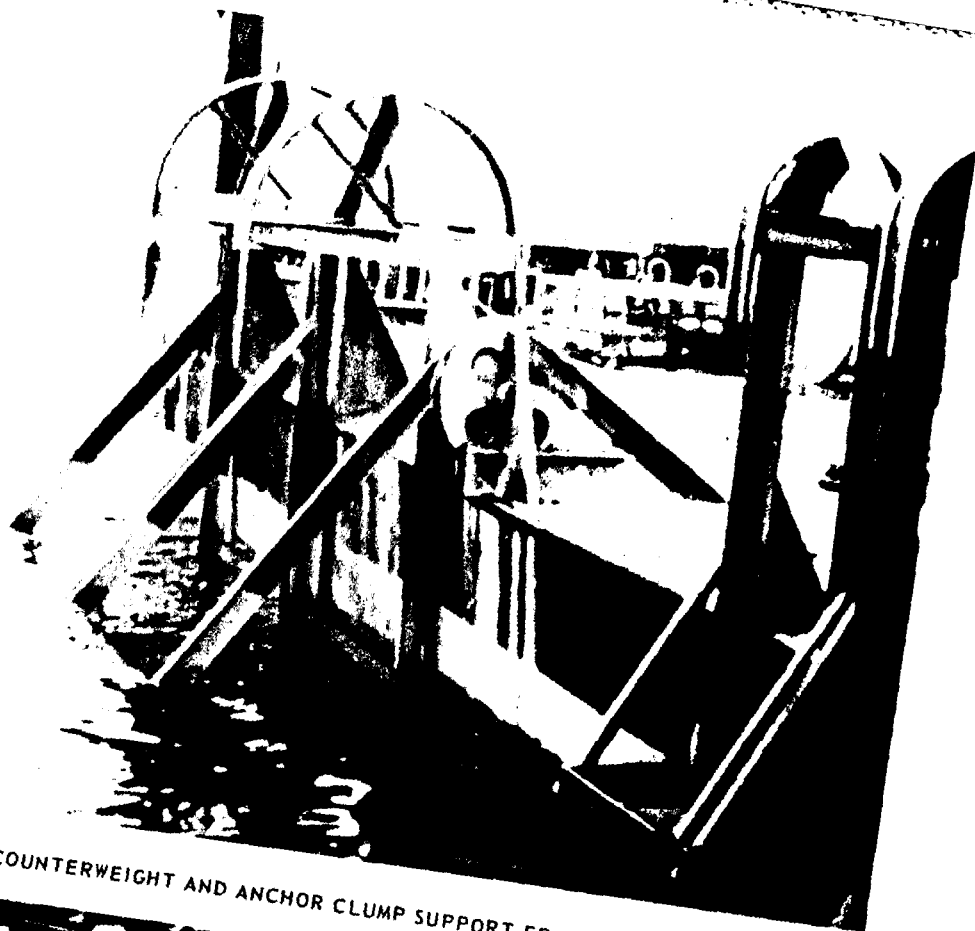
For lowering wire-supported loads over the stern, a fixed vertical sheave was installed on the fantail, Figures 40 and 41. The unit shown is the one that failed when the south anchor was being lowered; its replacement was shown earlier in Figure 24. The use of a fixed sheave of this type meant that every time a heavy load was to be lowered, the connection had to be made with the wire from the winch to the weight, and then the wire had to be lifted over the sheave. This meant that either the weight to be lowered had to be supported outboard over the stern in line with the sheave as the connection was made up, or the mobile crane had to be used to pick up the weight and wire to place it over the sheave; this latter type of operation was of course limited by the 12 ton capacity of the mobile crane.

To carry the heavy weights, or clumps, that were to be part of the total mooring system, the over-the-stern racks shown in Figure 41 were devised. The smaller units on the starboard side were designed to carry the 6000 pound (in water) weights that were a part of the mooring system and the larger units on the port side were designated to carry the large (28000 pounds in water) clumps used for counterweights in the vertical legs. The curved, half-pipe sections over the top of the racks were arranged for a supporting wire rope that could hold the weight of the clump and lower it down to where the weight could be transferred to a wire over the stern sheave. The diagonal support brackets leading to the bottom of the racks were arranged to be burned off when the weight was transferred from the rack to the cable above. These clump support brackets are of a more recent design than what had been proposed originally and are shown in the Project Execution Plan, Appendix II.

FIGURE 40. COUNTERWEIGHT AND ANCHOR CLUMP SUPPORT FRAMES

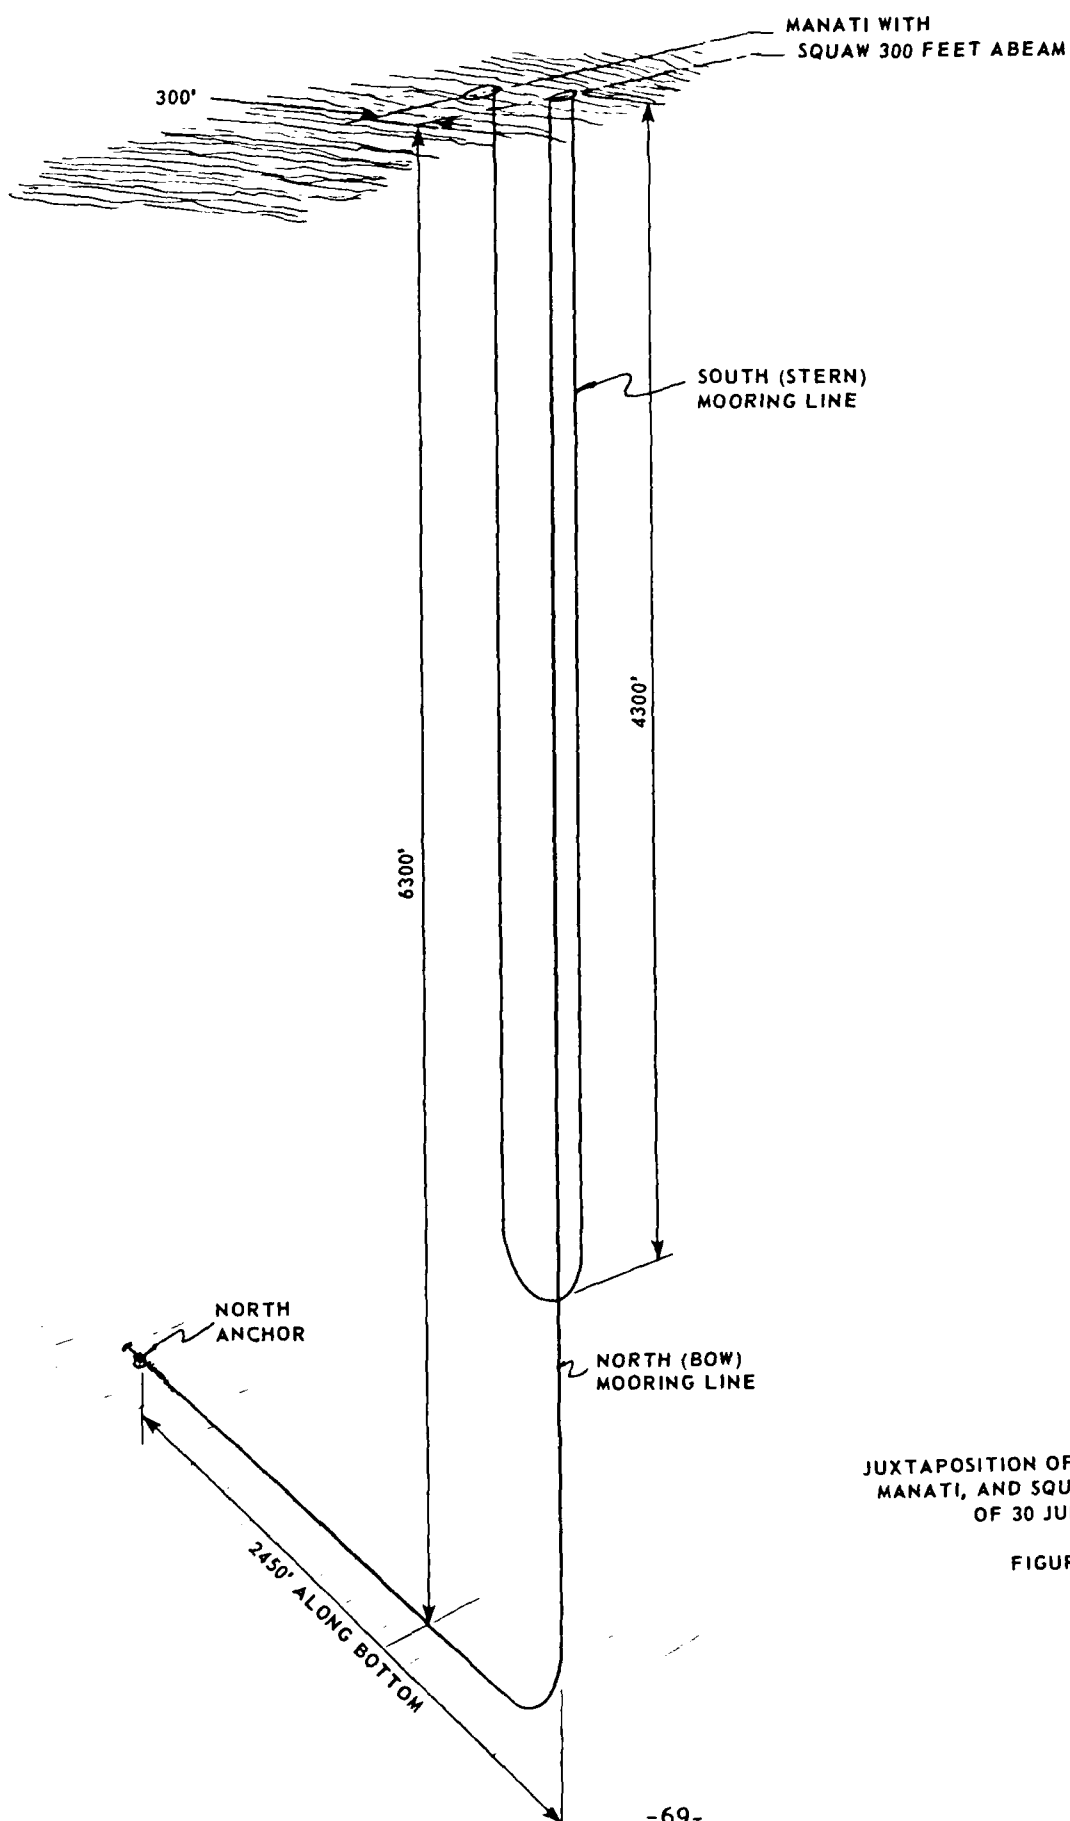
FIGURE 42

feet of chain. The water depth was 6300 feet. On the morning of 30 June, the *SQUAW* was just off the starboard beam of the *MANATI* and both vessels were within 2500 feet of the estimated anchor position. The proximity of the vessels and anchor is shown in Figure 42.

JUXTAPOSITION OF NORTH ANCHOR,  
MANATI, AND SQUAW ON MORNING  
OF 30 JUNE 1978

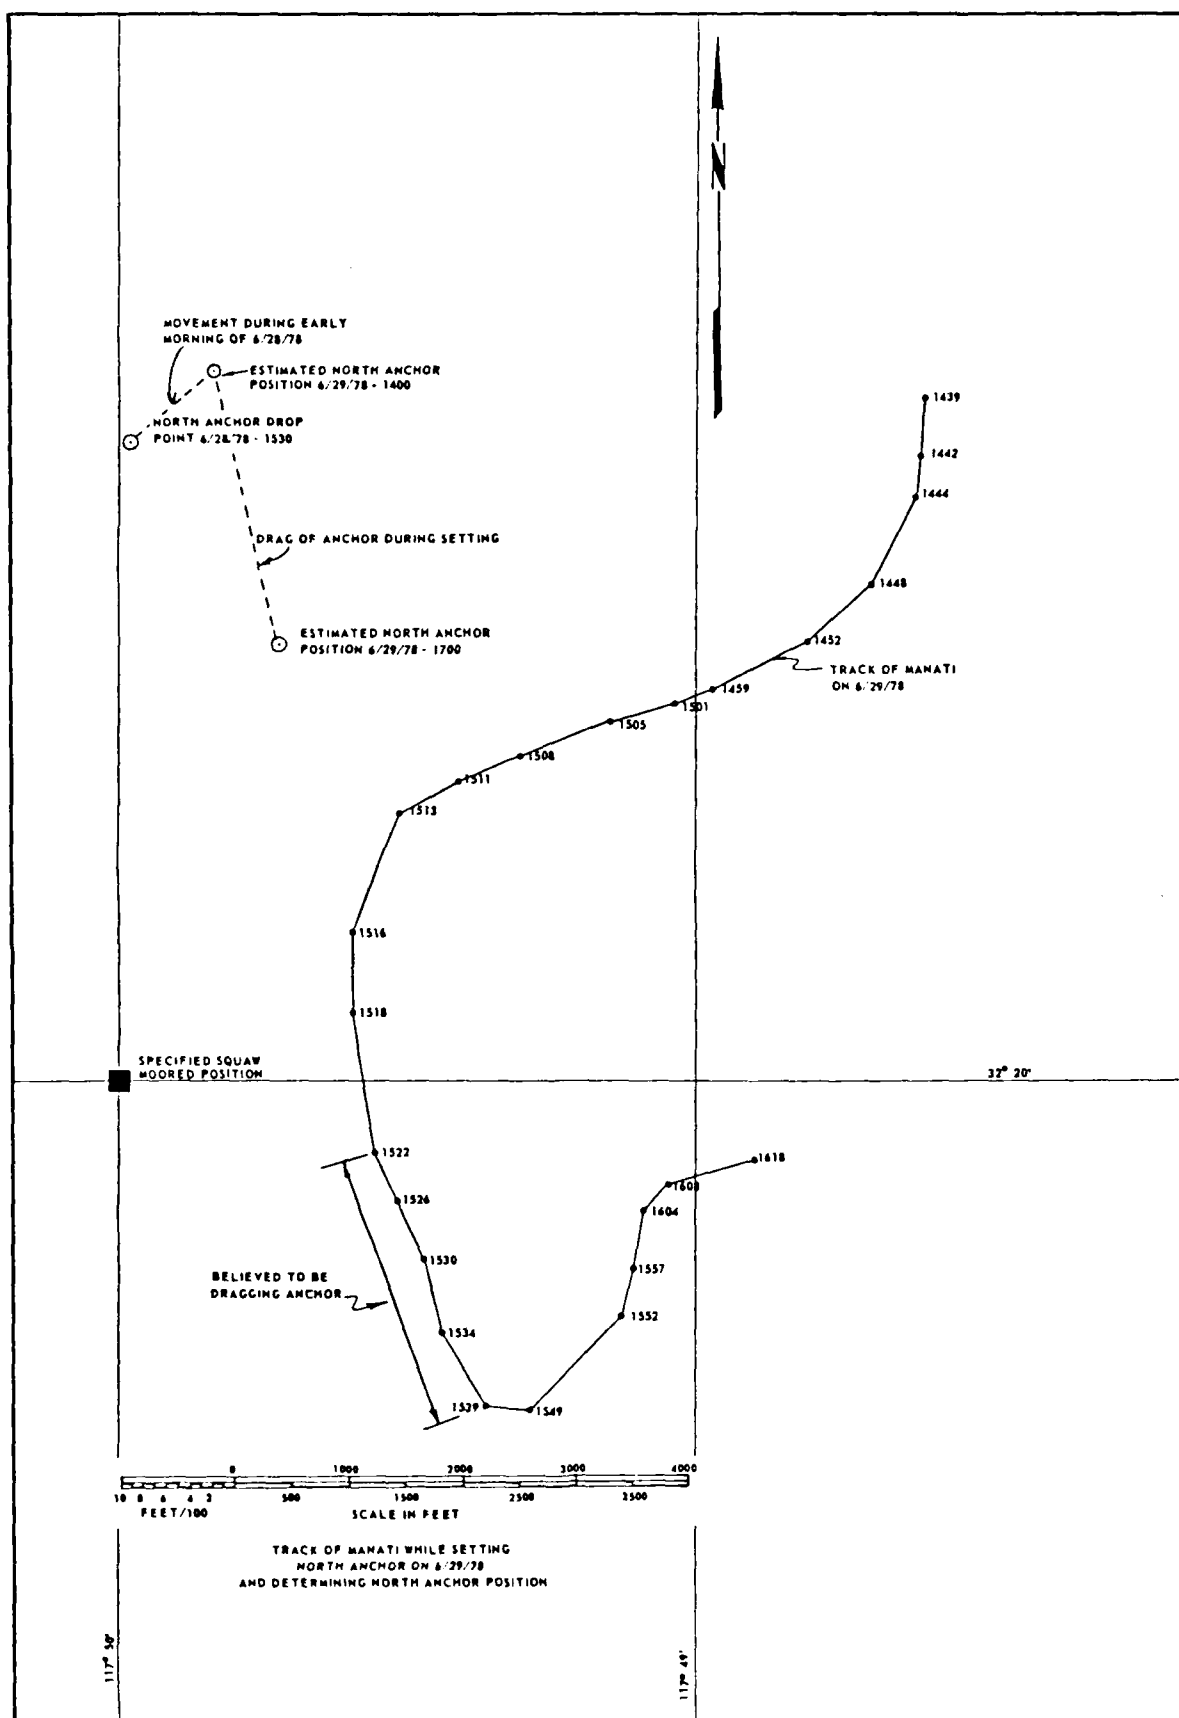
FIGURE 43. TRACK OF THE MANATI ON 29 JUNE 1978

There was a fairly heavy sea running and the forward mooring line, in resisting the downsea force applied to both the *SQUAW* and the *MANATI* angled out from the bow indicating that the loading was significant that night. However, on the morning of 29 June the seas were down and the chain at the bow of the *SQUAW* hung straight down. Yet the Mini-Ranger showed us to be 7000 feet northeast of the anchor drop point and it was reported that during the night we had been pulling *SQUAW* at *MANATI* headings of 060 and 070. Although there was no way of making a rational analysis of just what had happened to the anchor during the night, the best estimate was that it had moved 1000 feet to the northeast of the drop point as shown in Figure 43.

The maneuver shown in Figure 43 is the *MANATI* track that resulted from this planned exercise which started at about 1400 on 6/29/78. Then it was discovered that the *MANATI* by itself, with the *SQUAW* in tow, was incapable of executing the necessary maneuver as discussed earlier in Part IV. When the *MANATI* got to the point at 1500 where it should have headed southeast, a left rudder order was given. This caused the ship and tow to translate to the west and the planned 16000 pound pull to the southeast was never applied. During this period, the *CHALLENGER* was attached to the bow of the *MANATI*, mainly in an attempt to control her heading but at 1513 the *CHALLENGER* was ordered to pull the *MANATI* to the south. At this point the speed picked up from 2.11 knots to 3.45 knots until 1522 when the three vessels slowed down abruptly to a speed of 1.46 knots. During the period from 1522 to 1539 it was apparent that the north anchor was being dragged south with a pull of up to 25000 pounds or more being exerted as read on the *SQUAW* tensionmeter.

Thus, because of lack of control over ship maneuvers, and an apparent lack of communication as to the purpose of the exercise, the only outcome of this afternoon's work was to drag the north anchor to a point some 2200 feet southeast of where it was intended to be. Its estimated position at the end of the exercise is shown on Figure 43.

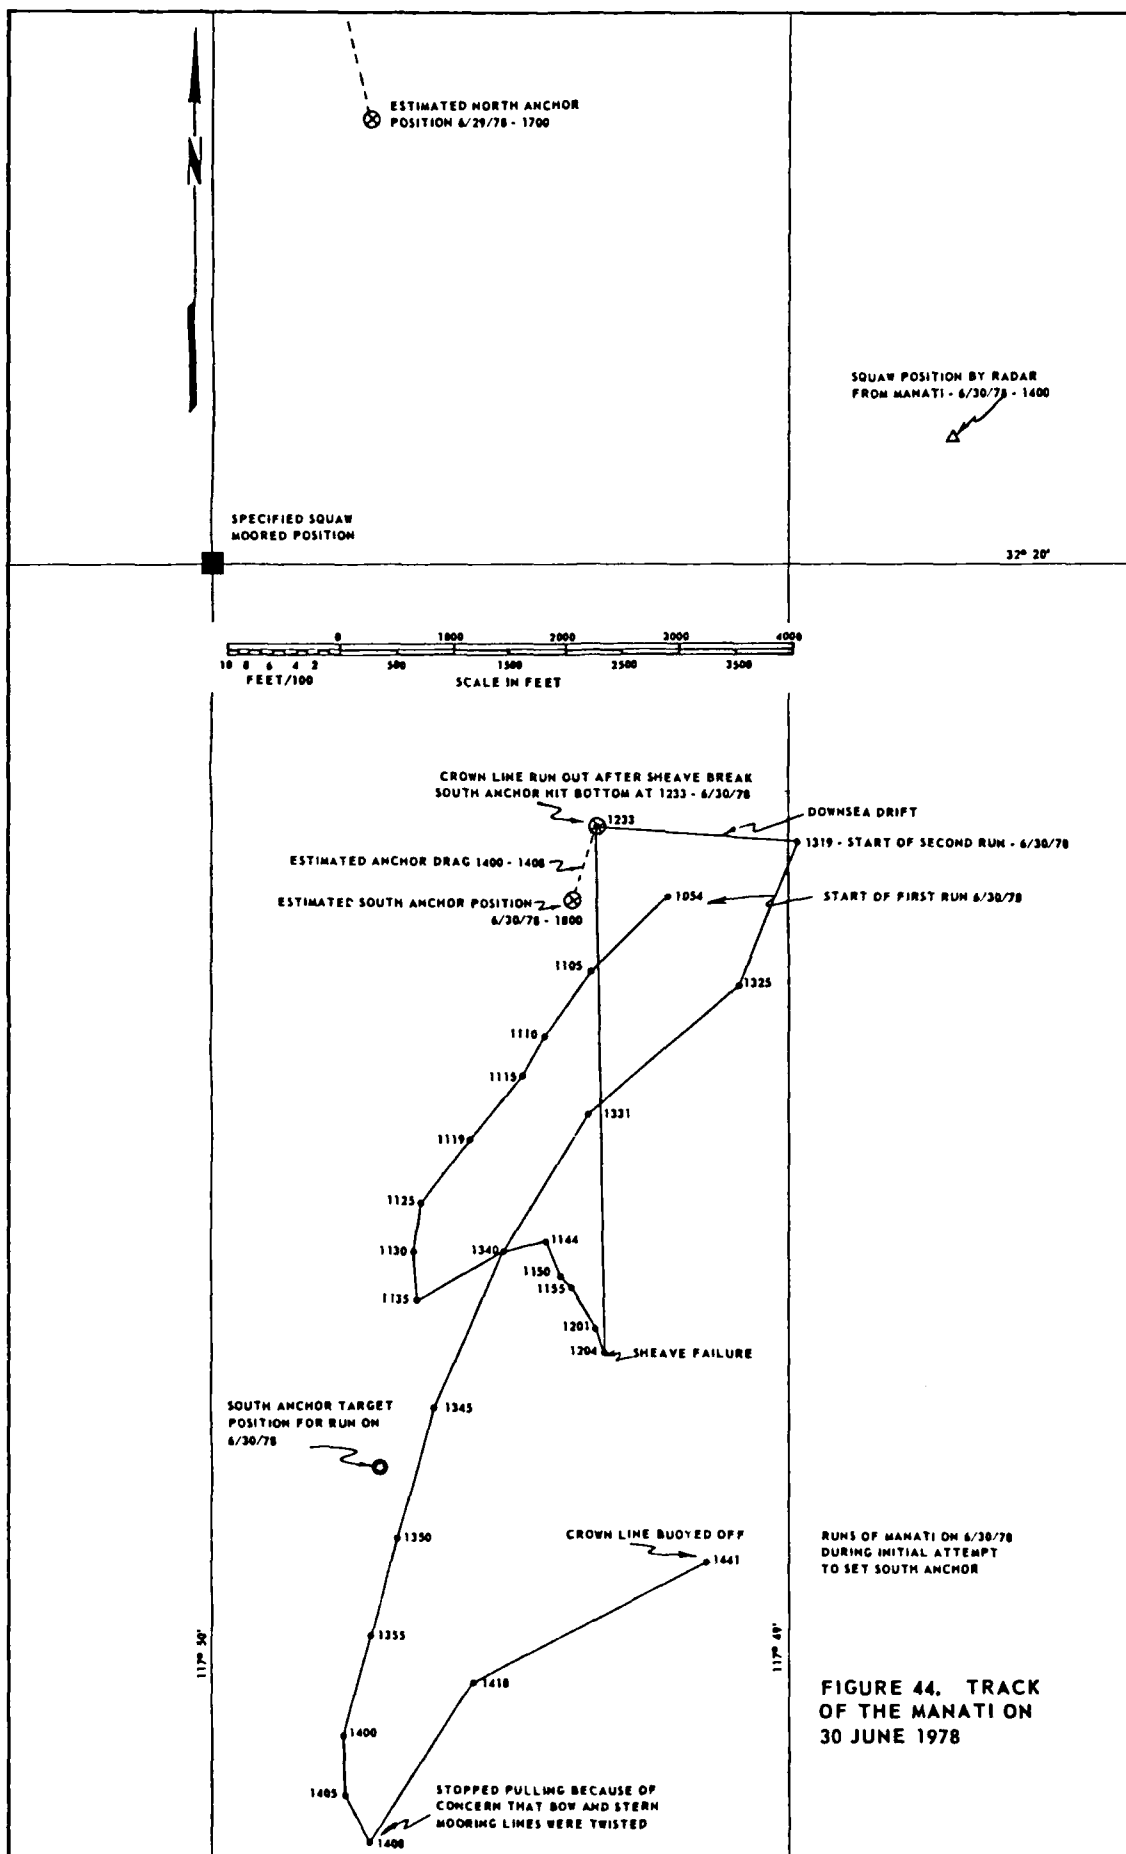
On the morning of 6/30/78 the *SQUAW* and the *MANATI* were next to each other in close proximity to the new north anchor position. The bow mooring line system connected the *SQUAW* to the anchor and there was 8570 feet of 1 1/4 inch wire hanging between the stern of the *SQUAW* and the stern of the *MANATI*. The remainder of the stern mooring line system including chain, clump, and anchor was made up as the *MANATI* moved slowly in a southeasterly direction. The anchor was lowered overboard at 0930 and about 4000 feet of crown line paid out. At about 1100 the *MANATI* got underway on one screw headed to the southeast as shown in Figure 44.

A new south anchor point had been established 12000 feet due south of the recently estimated north anchor position as shown. The plan was to run some 8700 feet south of this point while paying out 11000 feet of crown line. This crown line plus the length of wire in the stern mooring system was calculated to position the anchor on the bottom 6000 feet south of the *SQUAW* with the required tension of 33400 pounds in the north and south mooring lines with the anchors spread 12000 feet apart.

As can be seen in Figure 44 the *MANATI* started to slow perceptibly at 1125 as the *SQUAW* started to move. Up to this point the advantage of tracking the *SQUAW* with radar had not been realized but the submarine was kept under visual observation throughout. When the *SQUAW* started to move, the *MANATI* started to head away from the target position. Right rudder was ordered, and naturally the *MANATI* translated to port. At 1144 the rudder was moved amidships and the other propeller was cut in. For twenty minutes the *MANATI* was making headway to the south but at 1204 the stern sheave failed and the propellers were stopped. The horizontal force in the line due to the catenary immediately pulled the *MANATI* practically due north at an average speed of 1.6 knots for a half hour before the anchor was felt to hit bottom. At that point the remainder of the crown line was payed out and the south anchor position established.

By 1319 the *MANATI* drifted downsea about 1800 feet and a new run to plant the south anchor was initiated. The *SQUAW*, in the meantime, had drifted about 4500 feet east of a point halfway between the two anchor positions, approximately where it is shown at 1400 on Figure 44. The *MANATI* again headed for the south anchor target point, passing it at a speed of about 2.7 knots. This speed dropped to one knot when the *MANATI* was about 3000 feet south of the target point. A radar reading taken on the *SQUAW* showed it to be at a distance of about 13000 feet; at this point there was about 20000 feet of line out between the two vessels and the *SQUAW* was obviously moving, but broadside to the line of tow. Because of concern that the north and south mooring lines might be crossed and twisted, the towing for the day ceased and the crown line was buoyed off. After analyzing the data from the day's activities, a new position for the south anchor was estimated as shown in Figure 44.

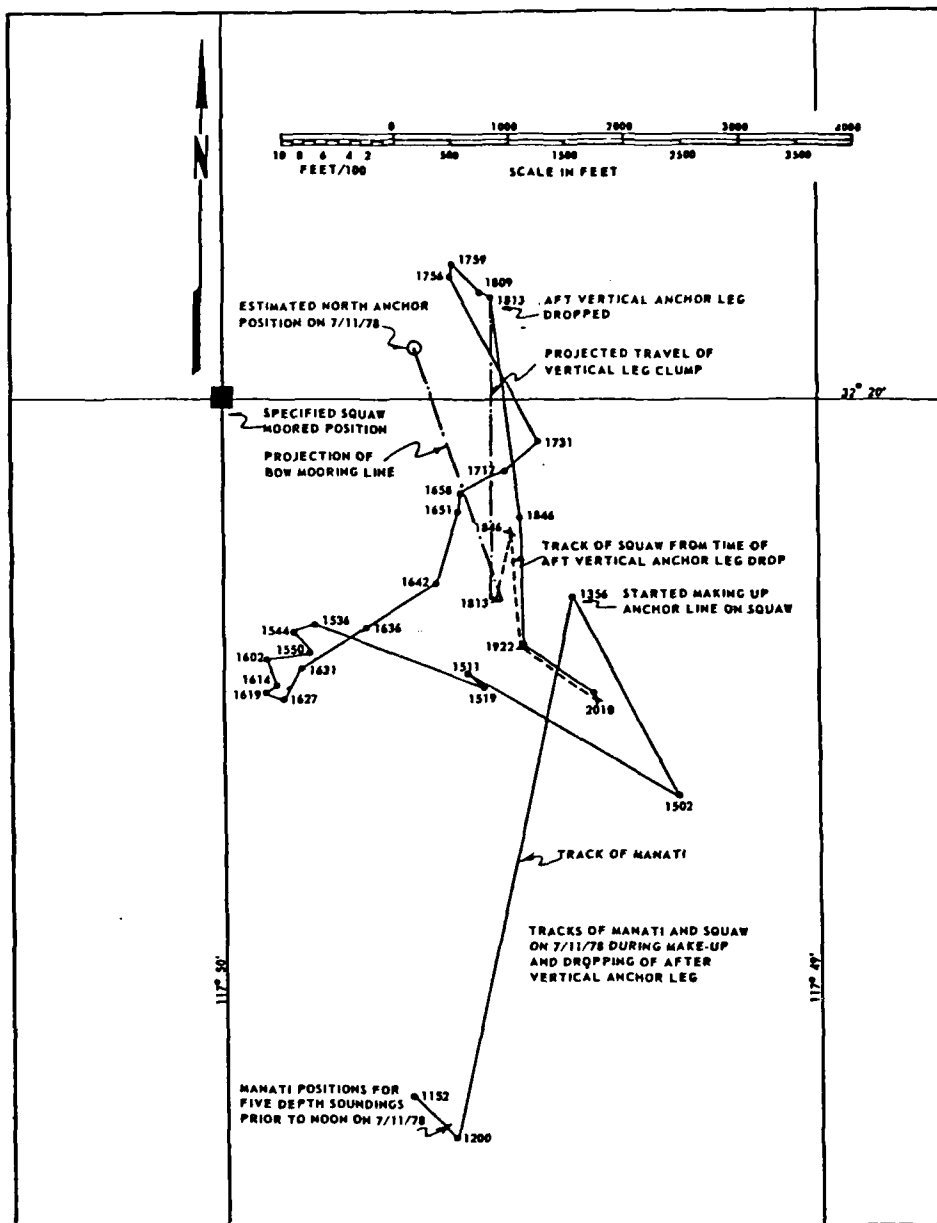
FIGURE 46. TRACKS OF THE MANATI AND SQUAW ON 11 JULY 1978

After taking soundings at the proposed *SQUAW* moored location the *MANATI* headed for the *SQUAW* at noon, backed down on the port side of the submarine, and at 1356, as shown in Figure 46, started making up the after vertical leg. During the period between noon and 1356 a 180 foot length of chain had been cut and the end of the 5740 foot vertical wire was shackled to it. When the *MANATI* backed down on the submarine, the 90 feet of chain secured to the after padeye on the bottom of the *SQUAW* was cut loose from it. deck lashings. The end of the 90 feet was then pulled aboard the *MANATI* and secured to the 180 foot chain. The chain was then eased overboard.

As related earlier, the acoustic release did fail at 1813 and the vertical leg and clump dropped into position. At the instant of release, the Mini-Ranger position and heading of the *MANATI* and the radar range and bearing of the *SQUAW* were recorded. *MANATI* heading was 335° True, *SQUAW* range was 2700 feet, and relative bearing was 203°. The potential for interference between the bow mooring and the after vertical leg is shown graphically in the projections of the mooring line and the travel of the vertical leg clump given in Figure 46.

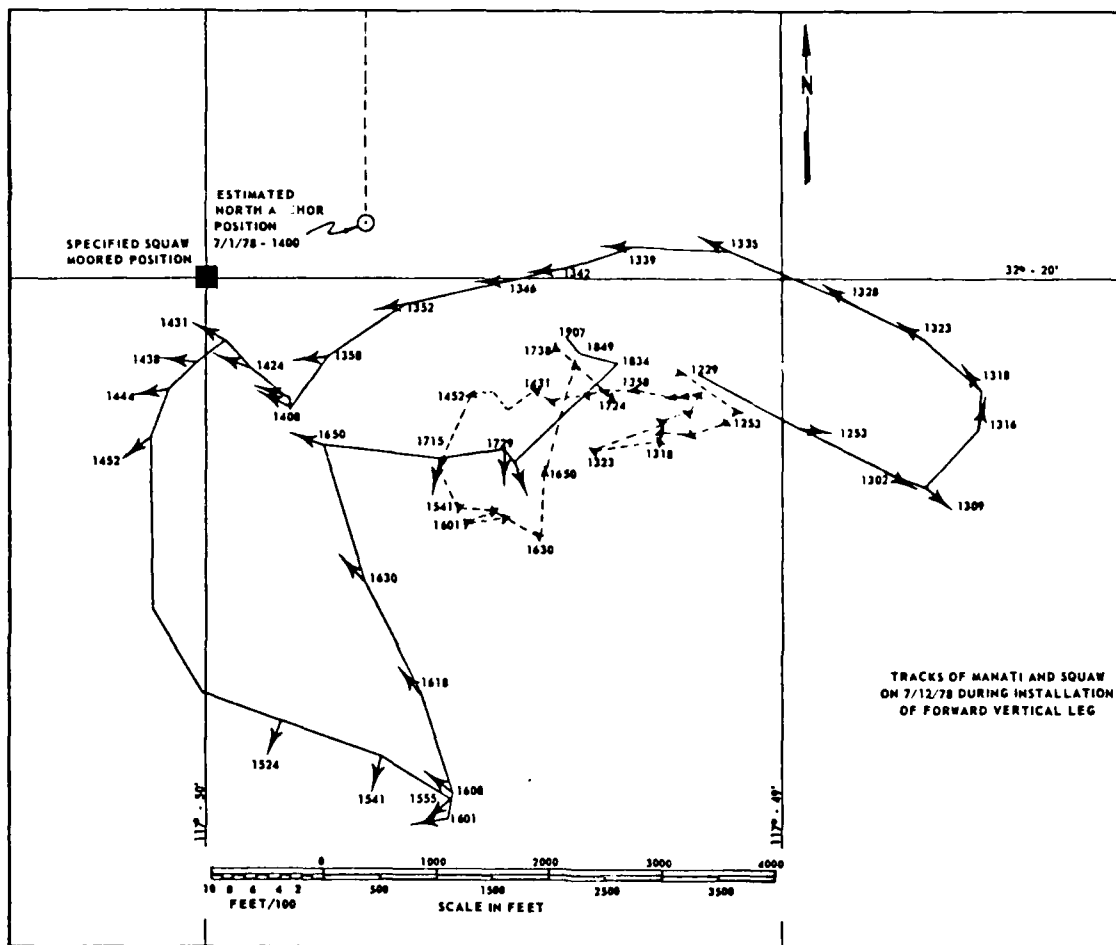
FIGURE 47. TRACKS OF THE MANATI AND SQUAW ON 12 JULY 1978

Just before noon on 12 July 1978, the *MANATI* moved over to the *SQUAW* to shackle up the chain on the forward padeye below the submarine to the chain on the deck of the *MANATI*. At this time the *SQUAW* was headed at 105° true with its stern upsea toward the north anchor about 3000 feet from the estimated anchor position as shown in Figure 47.

As described earlier, and as depicted in Figure 47, it is almost certain that, when the forward vertical leg was lowered it was actually wrapped clockwise, looking downward, around the bow mooring line. Furthermore, it is believed that the lowering line, connected to the forward counterweight, then followed a path upward and counterclockwise to the point where it was secured to the after port mooring bitts of the *SQUAW*. Thus, both the vertical leg and its lowering line were wrapped around the bow mooring line. The mooring line generally followed a catenary from the bow chock to its anchor, and since the forward leg was hanging directly down from a point on the bottom 35 feet aft of the bow, thus the chains at the tops of the vertical leg and the mooring line probably crossed a short distance below the hull whereas the crossing of the lowering line and the bow mooring line was probably far below the surface.

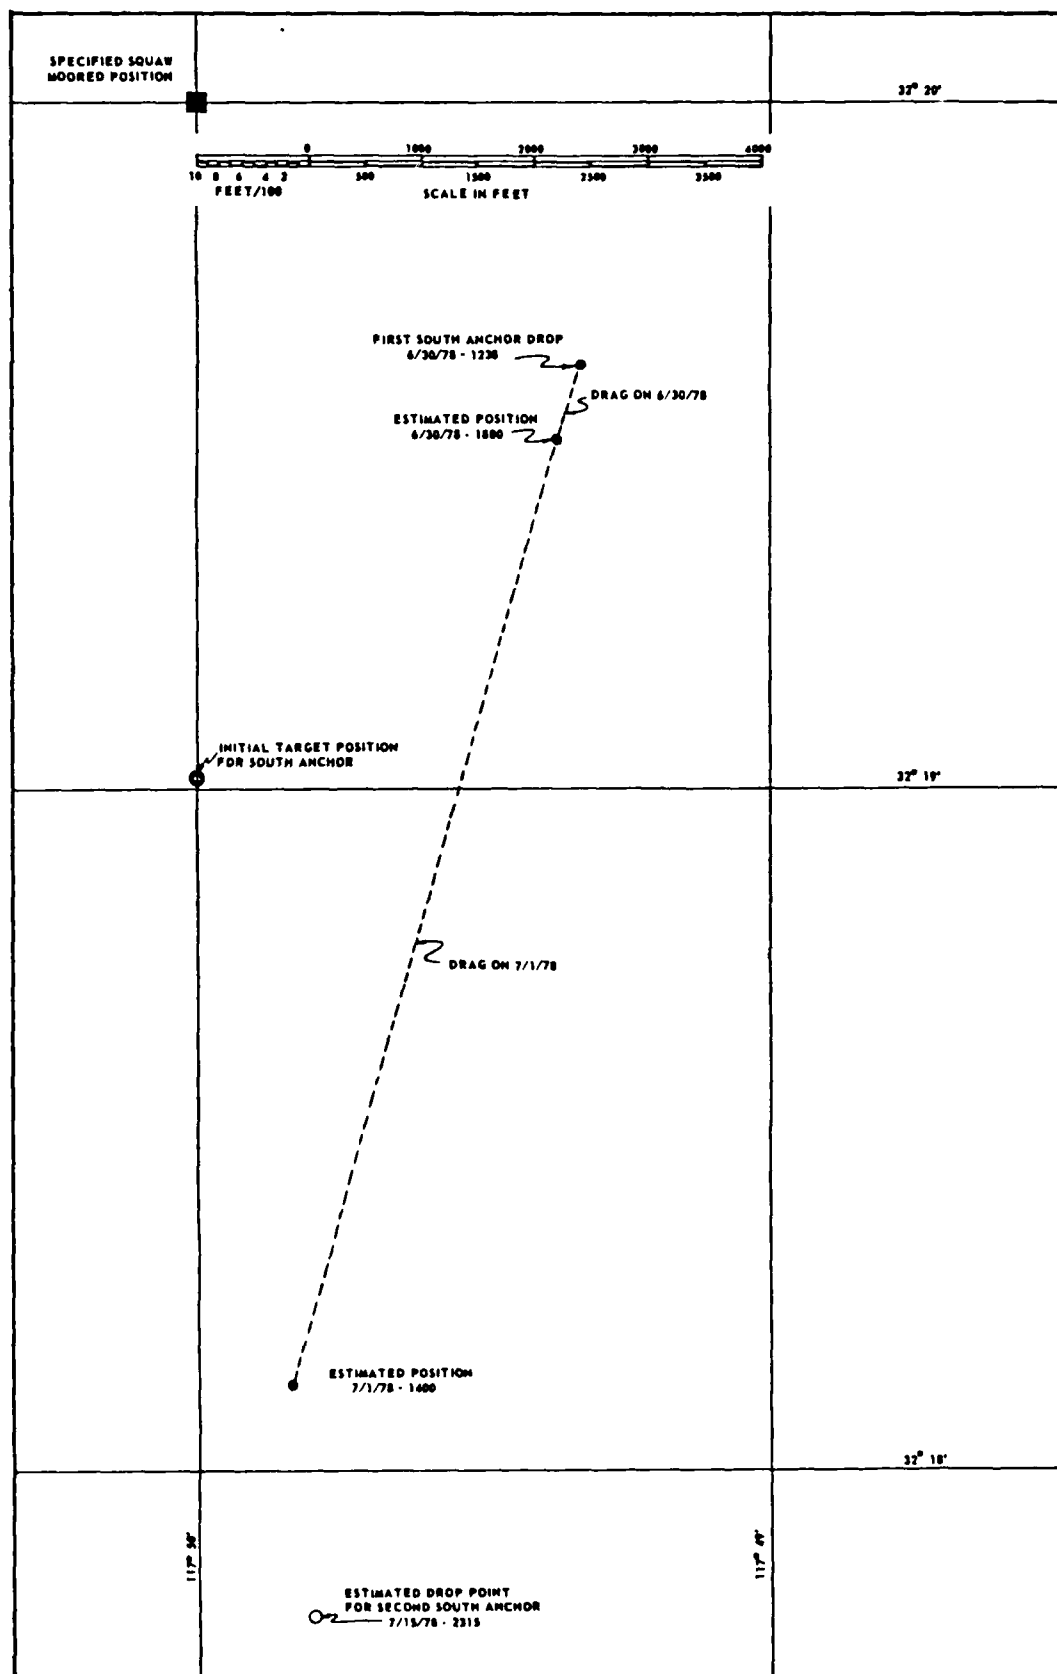
FIGURE 50. POSITIONS OF THE TWO SOUTH ANCHORS

The position of the first and second south anchors, on the other hand, while not known as precisely originally were subjected to far less movement. Therefore, the positions shown in Figure 50 are probably reasonably accurate.

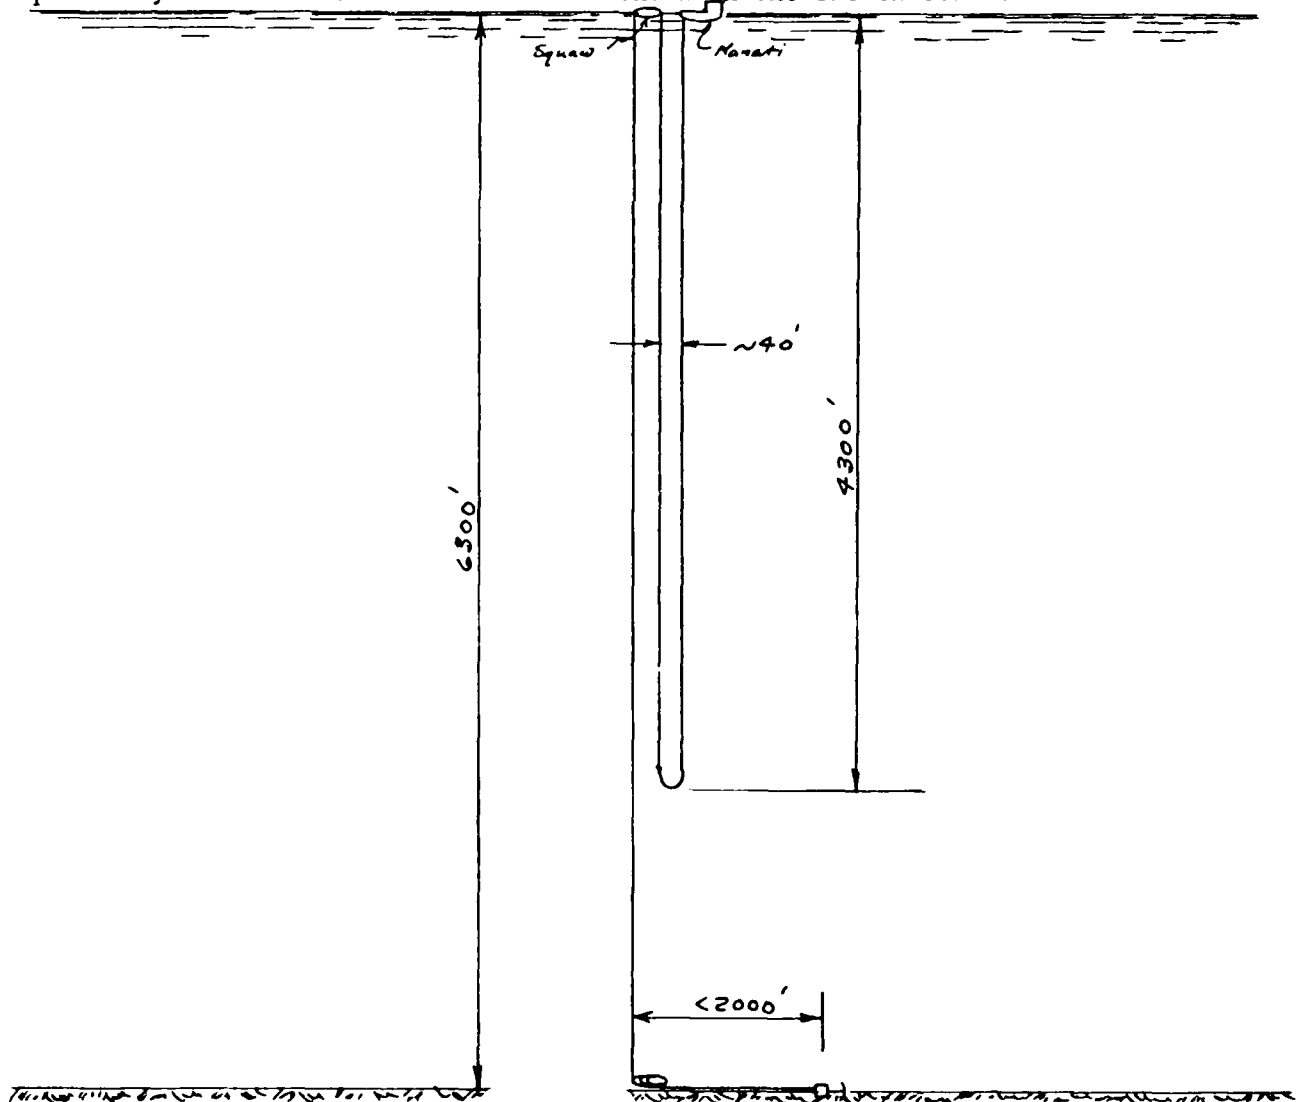
On the evening of 6/29/78 the SQUAW was between the MANATI and the place where we estimated the north anchor to be. From all later observations this estimate seemed reasonably accurate. At dark the SQUAW was well to the south-east of the anchor point and the MANATI was well to the southeast of the SQUAW. Between the SQUAW and the anchor point was 45 feet of chain, 8570 feet of wire rope, and 180 feet of chain. Between the MANATI and the SQUAW was 8570 feet of wire rope plus 45 feet of chain. The water depth was 6300 feet. On the morning of 6/30/78 the SQUAW was just off the starboard beam of the MANATI and both vessels were within 2000 feet of the estimated anchor position. The proximity of the vessels and anchor is shown in the sketch below.
